EXHIBIT C

STATE OF SOUTH CAROLINA)	IN THE COURT OF COMMON PLEAS
)	CASE NO.:
COUNTY OF BEAUFORT)	
)	
Jill Demark,)	
)	
Plaintiff,)	
)	<u>COMPLAINT</u>
-vs-)	(Jury Trial Demanded)
)	
Jetson Electric Bikes, LLC, and)	
Amazon.com, Inc.)	
)	
Defendants.)	
_____)

Per your request, CORE Engineering has completed its engineering analysis of a fire that damaged rental property owned by Jill Demark. The property's address was 66 Mroz Road, Beaufort, South Carolina. The purpose of the engineering analysis was to determine the origin and cause of the fire. This report contains CORE's present findings and opinions. If necessary, CORE will supplement its report to the extent that additional relevant information becomes available.

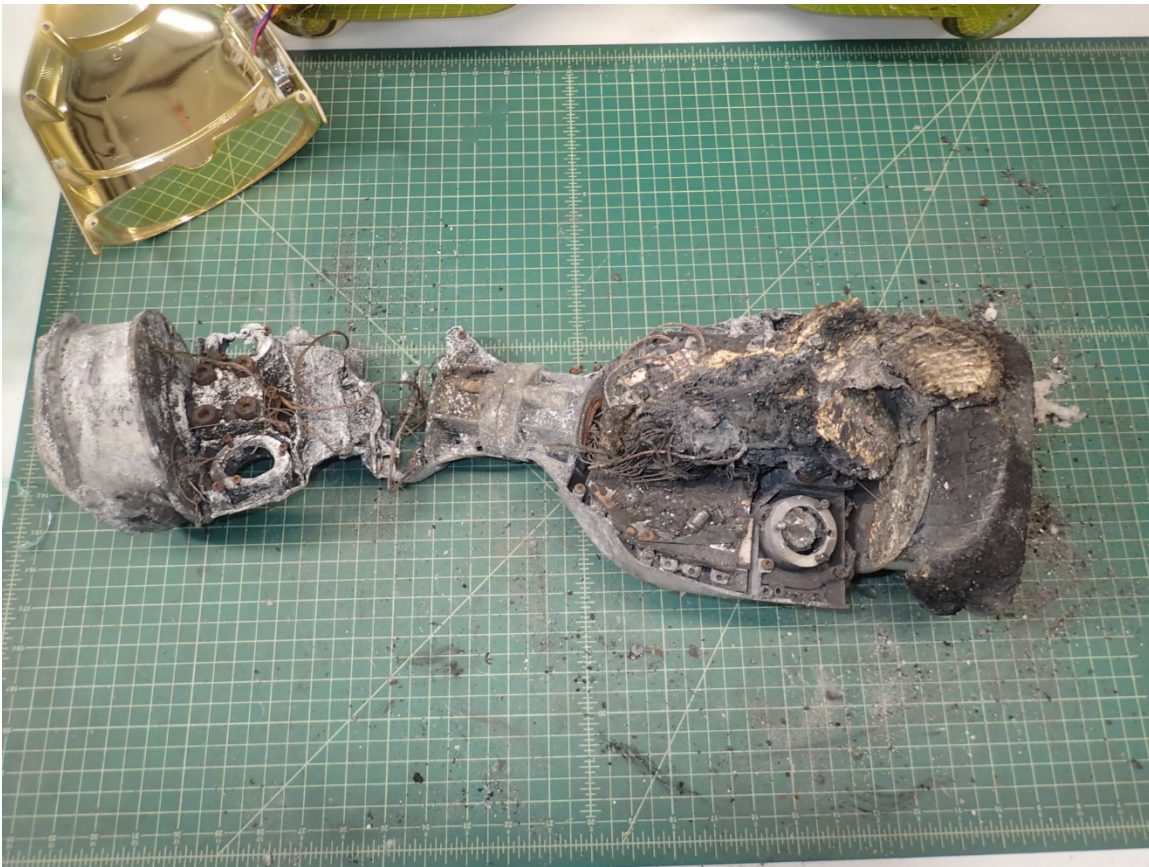
Examination of the artifacts continued with the remains of the subject hoverboard. It appears the hoverboard sustained heat damage from the exterior, as opposed to the interior, because the melted aluminum casing protected the batteries and circuitry for the hoverboard until the insulation for the battery cells was compromised, melting the portion of the casing where the battery pack was located, as shown in **Figure 13** through **Figure 15**. Examination of the hoverboard revealed that the main motor board and the two balancing boards were intact and exhibited no signs of electrical arcing and shorting in the form of melted copper as seen in **Figure 16** and **Figure 17**. Close examination of these X-Ray images revealed the soldered electronic components of the hoverboard control system were not melted and still intact. It is important to note that solder melts at 361°F and aluminum melts at 1,200°F, so if the fire started in the interior of the hoverboard the solder would have melted, but it did not.

Figure 13: Remains of subject hoverboard.

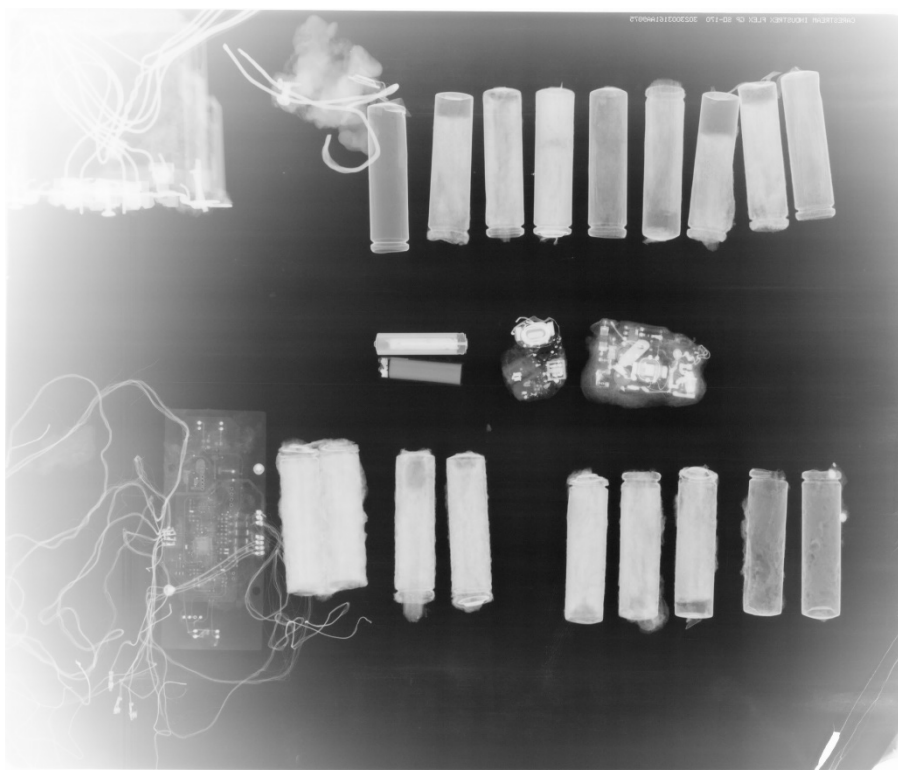
Figure 16: X-Ray image of batteries and balancing board adjacent to battery pack for subject hoverboard.

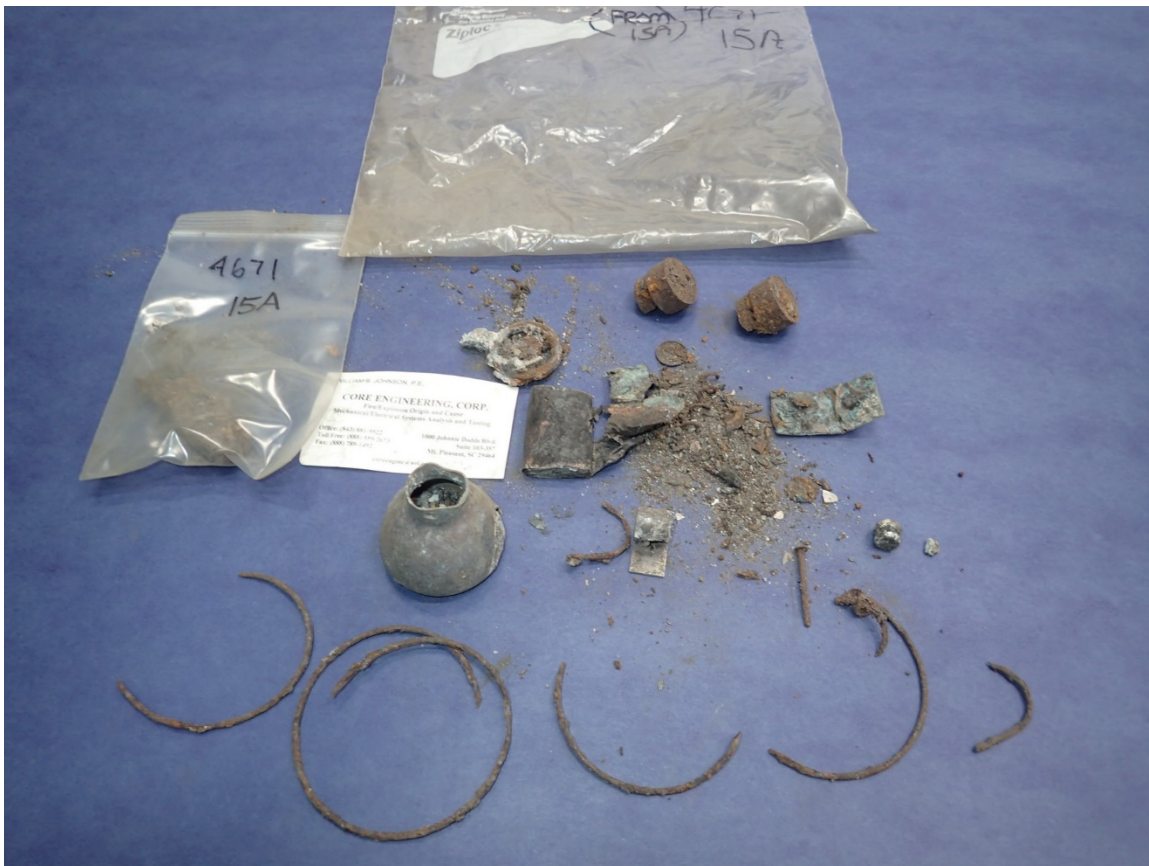
Examination of the artifacts of interest continued with the electrical artifacts found in the area of fire origin as determined by CORE Engineering, as seen in **Figure 18**. Examination of the artifacts did not reveal evidence of the plug blades that would have been plugged into the outlet, or the power cord for the battery charger. Close examination of these artifacts revealed evidence of one board severely damaged that may have been related to the battery charger, as seen in **Figure 19**. However, due to the extensive damage of the board, it could not be eliminated as a cause of the fire.

Figure 18: Electrical artifacts from area of fire origin determined by CORE Engineering.

Therefore, it is the opinion of S-E-A that the subject hoverboard, found in the area of origin identified by CORE Engineering, was not the cause of the fire, and the unknown battery charger and its associated power cord cannot be eliminated as the cause of this fire.

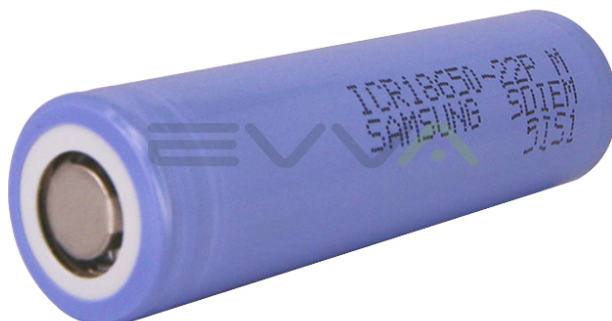
Figure 21: Image of Samsung 22P battery with three-hole vent.

Since all lithium-ion 18650 battery cells have the same dimensional characteristic of being 18-millimeters in diameter and 65.0-millimeters in length, identification of a lithium-ion cell is dependent on several characteristics. Identifying the cell is important to determine the electrical capacity of the battery cell, as well as knowing what testing of the battery cell would have been subjected to during its design and manufacturing. In the past, simply looking at the configuration of the positive tab with vent holes was a leading indicator of determining the manufacturer. Examination of the subject 18650 battery cells associated with the subject hoverboard revealed they had a four-hole positive tab vent, while all of the Samsung SDI 18650 battery cells have a three curved hole pattern on the positive tab, as seen in **Figure 20** through **Figure 22**.

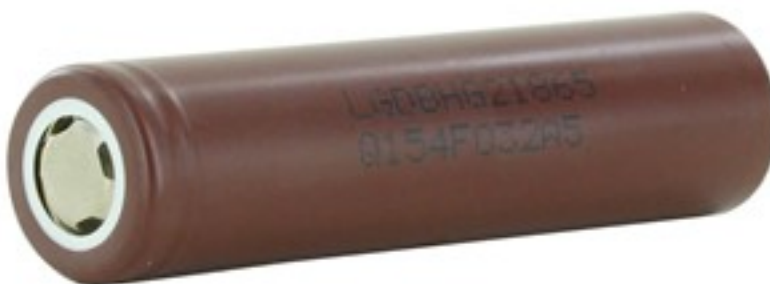
Figure 22: Image of LG Chem battery with four-hole positive tab vent.

Currently, there are a number of manufacturers that have the same four-hole positive tab vent hole configuration as the subject battery cells. For example, the Efan, Imren, and Efest have the same vent hole configuration even though other manufacturers have copied this design. However, according to the ETP Report the battery cell is possibly manufactured by LG Chem and not Samsung.

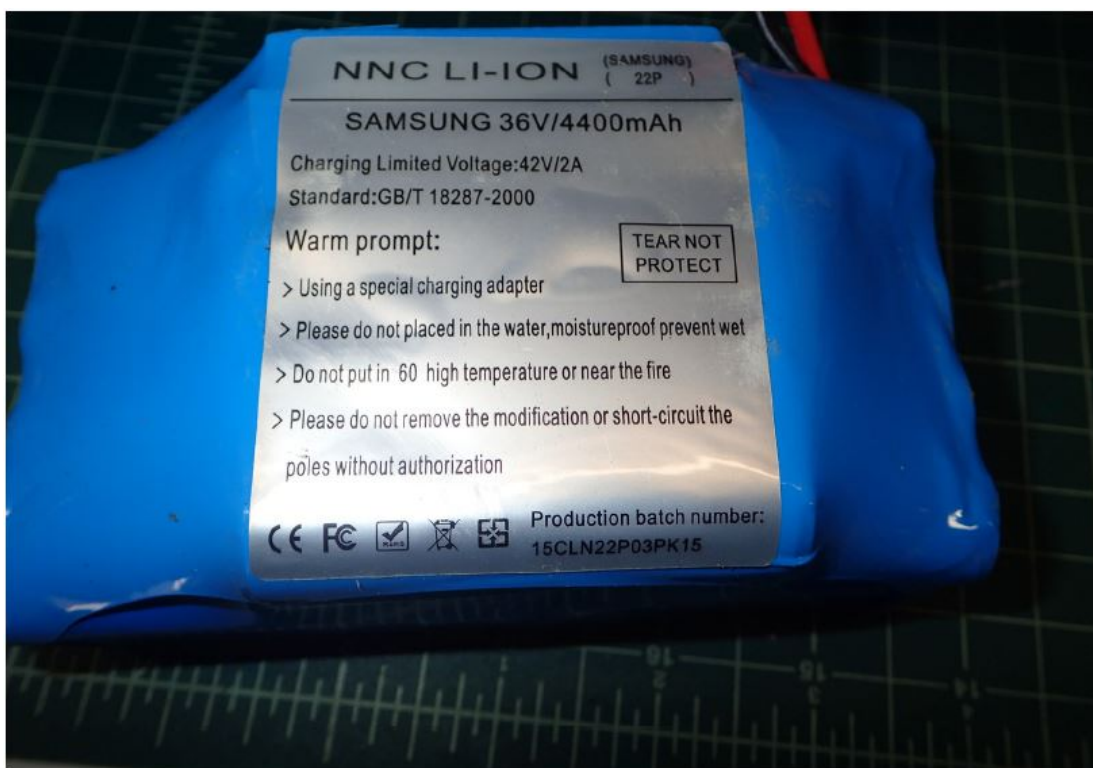
Figure 27: CORE Engineering photograph of battery pack for a hoverboard.

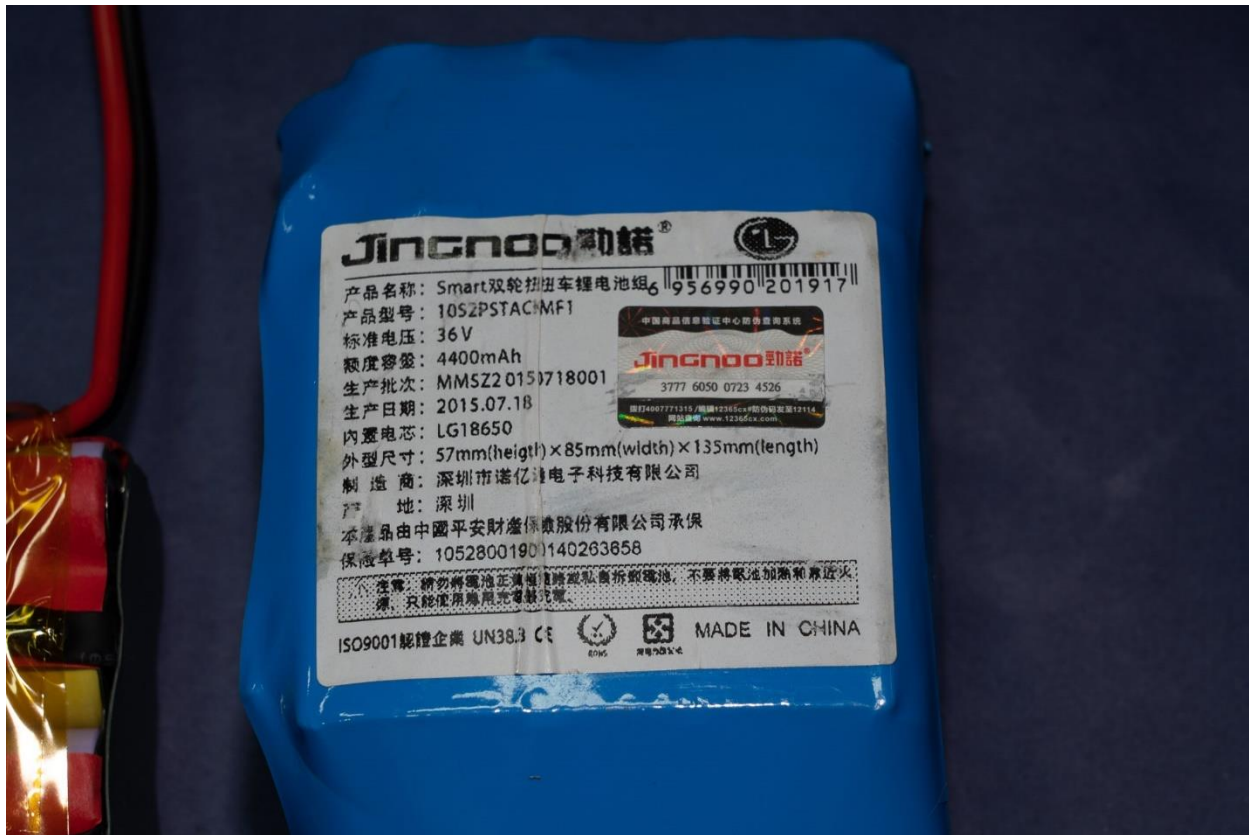
Figure 1. A photograph showing the label on a 36 V 4400mAh battery pack removed from a hoverboard and containing cells marked “LG”.

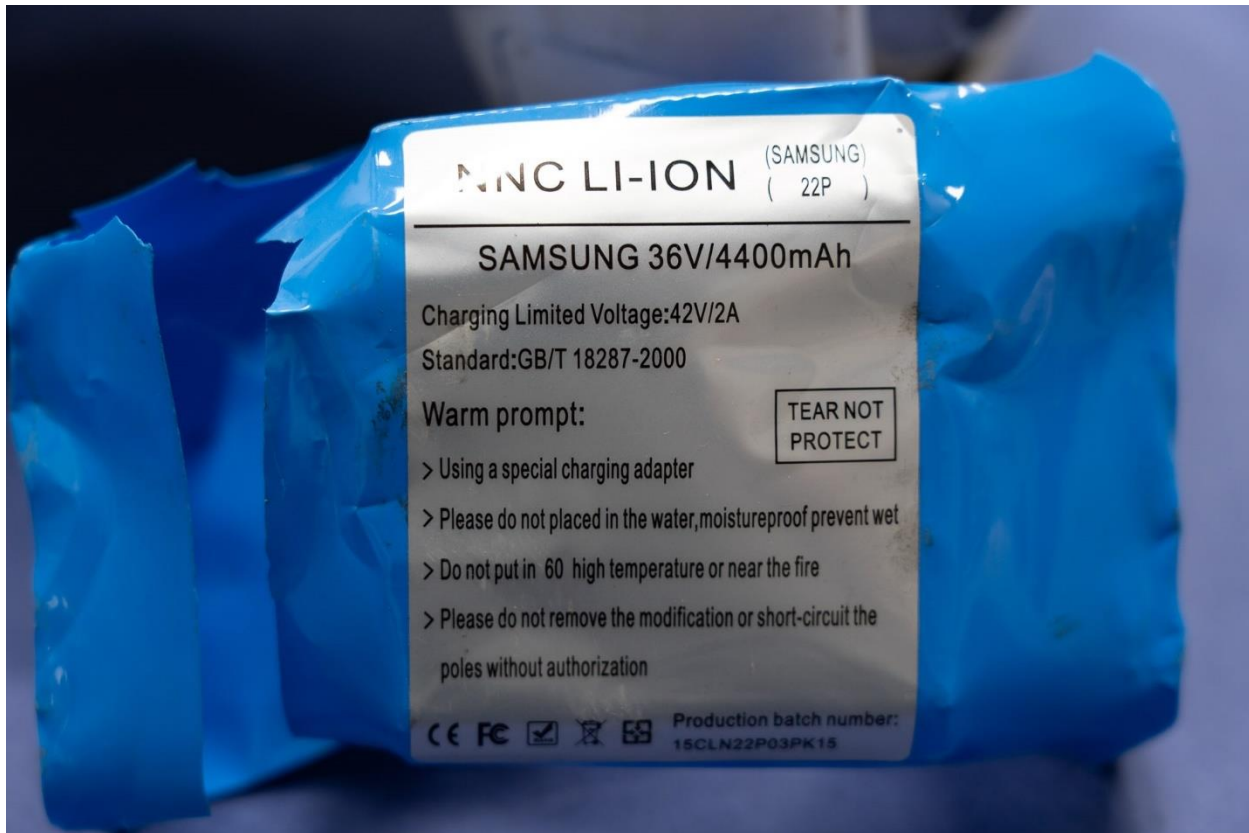
Figure 4. A photograph showing the label on a 36 V 4400mAh battery pack removed from a second hoverboard and containing cells marked “Samsung”.

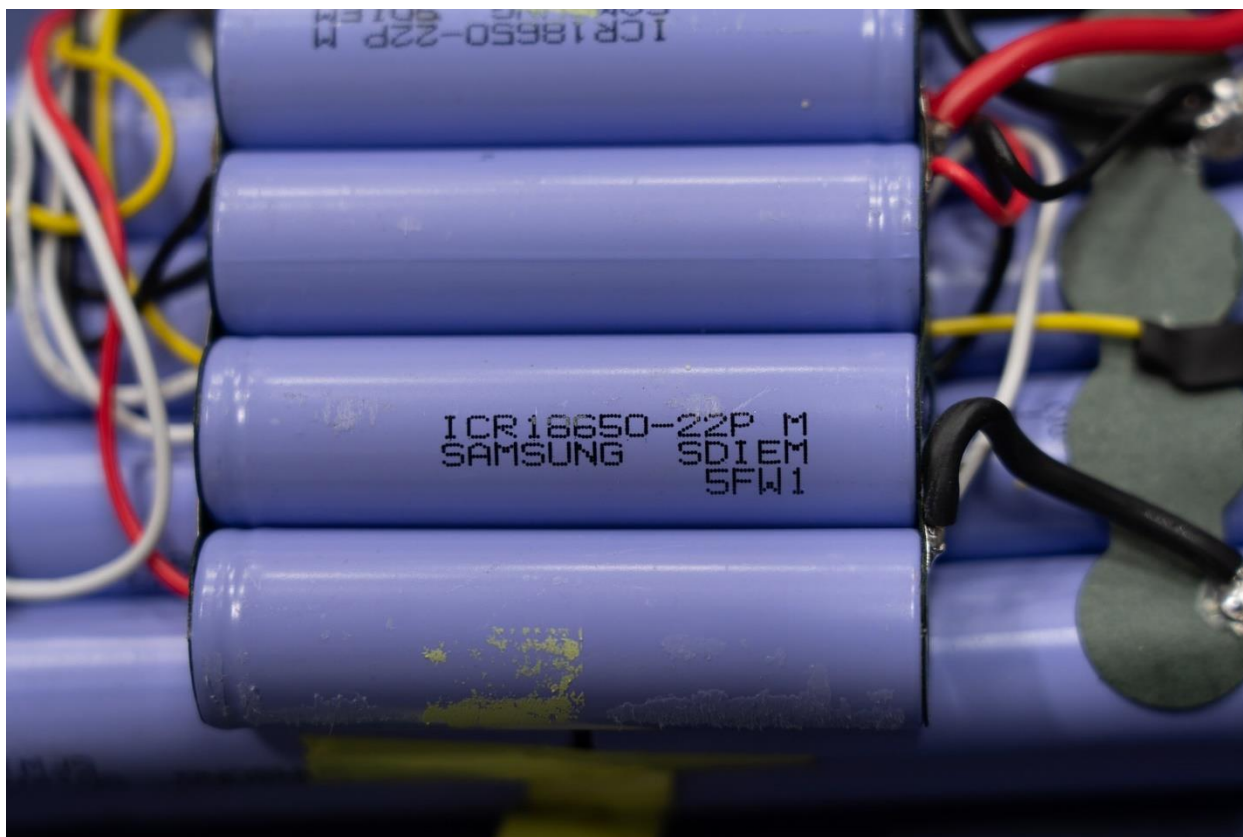
Figure 6. A close-up view of the markings on a single cell.
